Cleaning the Adolphe Roger murals at the church of Notre Dame de Lorette, Paris

Méliné Miguirditchian, Nicolas Engel, Laetitia Desvois
and Anne-Laure Capra

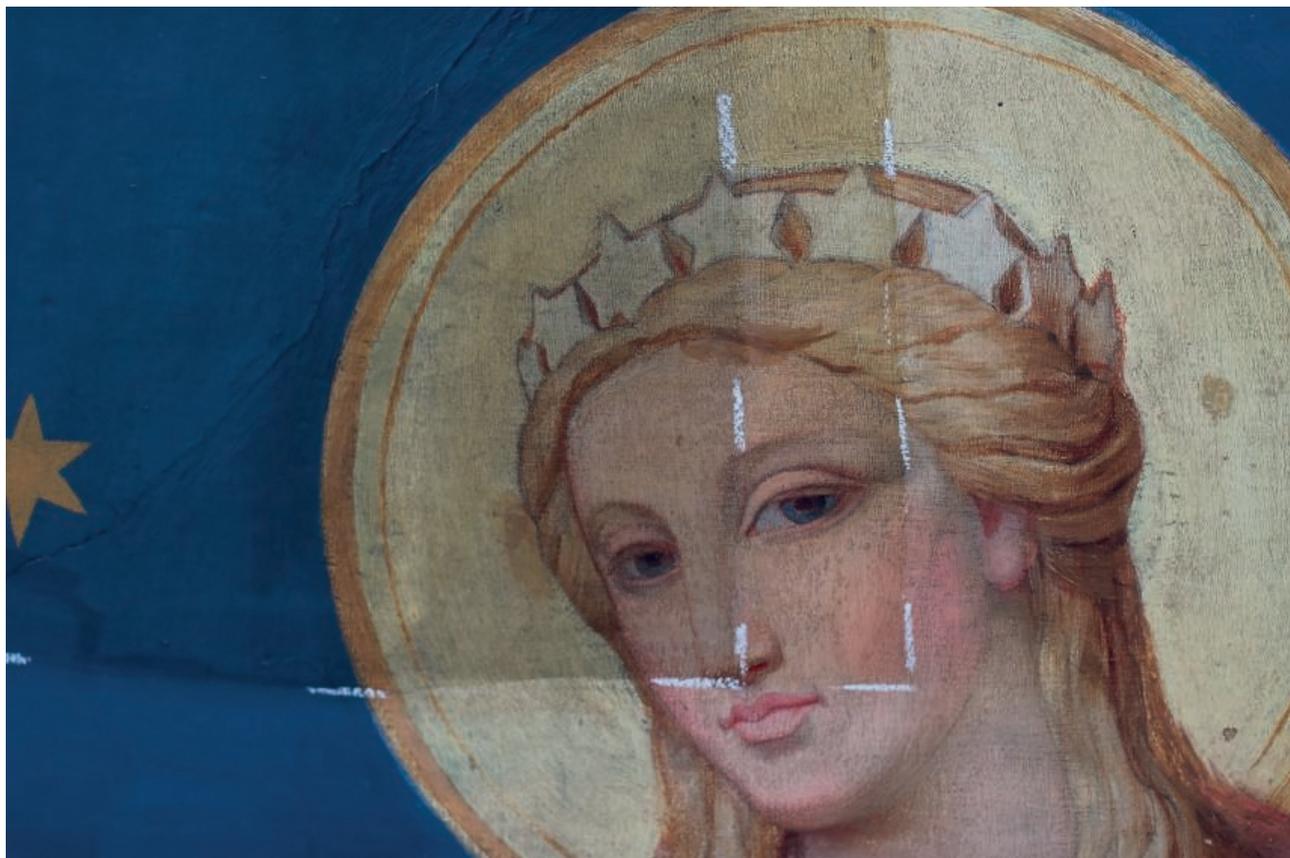
FIG. 1 Details of the removal of the two layers of varnish (photo ©Julien Horon).

Understanding the painting technique used by Roger was the starting point for the entire treatment, including the varnish removal. Once the artist's technique and the various types of varnish had been identified, it was necessary to find a method for removing these two coats of varnish without causing swelling in the mixed gluten compounds. A process was developed using a solvent in a water-based emulsion to remove the two coats of varnish, with the assistance and participation of Richard Wolbers when he visited the site. We chose a 10% benzyl alcohol emulsion in a slightly basic aqueous gel containing 2% xanthan gum, buffered to pH 8. The emulsion was applied with a brush

and cleared with water buffered to pH 7. The dwell time was about two minutes.

This emulsion was first tested on several scenes and various colours (Fig. 1). These tests were highly encouraging and it was possible to start removing the varnish. Cleaning started in the dome and progressed to the two lower levels. This particular emulsion made it possible to clean the surface gradually and evenly, without blanching the paint layer (Figs 2–5). The matte finish of the paintings was revealed when the varnish was removed. The low toxicity of the emulsion represented a considerable advantage for the members of the conservation team. The emulsion was easy to prepare and use, making it possible to remove both coats of varnish from a significant total area of 250 square metres.

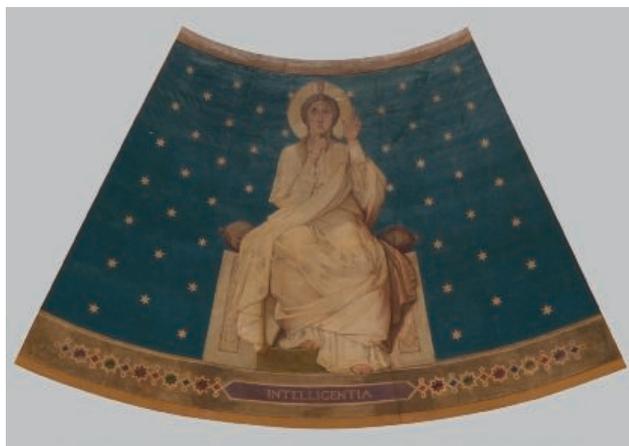
FIG. 2 *Intelligentia*: before cleaning (photo © Julien Horon).

Analysis revealed two superimposed coats of varnish. The first coat, in direct contact with the painted layer, was an oil-based varnish containing rosin-type diterpene resin. According to archival documents, two earlier restoration campaigns had taken place – one in 1859, the other in 1933. This oil- and rosin-based varnish was certainly applied during one of these two restorations. The significant thickness of this oil-based varnish was clearly intended to camouflage previous damage to the paint caused by aggressive cleaning methods. This varnish had oxidized and taken on an orange tint over the years. Further analyses then revealed the presence of another, synthetic, acrylic varnish, applied during the most recent restoration in the 1980s. We can assume that the cleaning during this restoration had reduced the matte appearance of the first varnish, so the restorers at that time were obliged to apply more varnish.

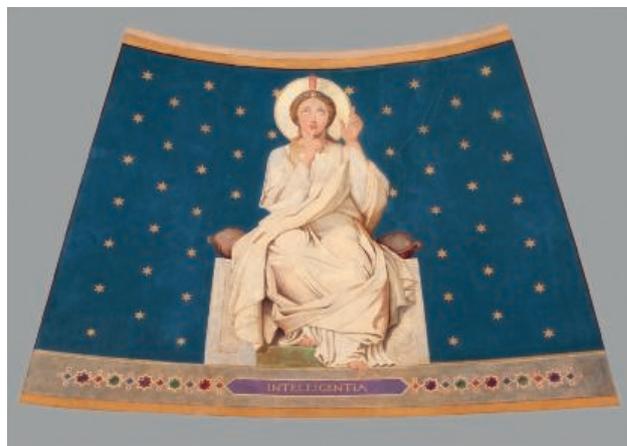
FIG. 3 *Intelligentia*: after treatment (photo © Julien Horon).

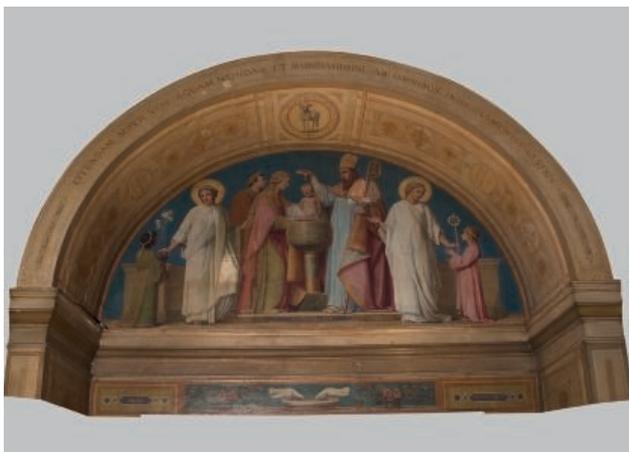
FIG. 4 *Baptimus aquae*: before cleaning (photo © Julien Horon).

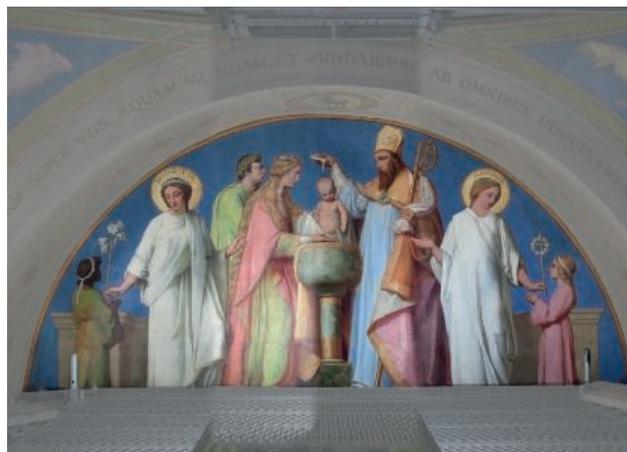
FIG. 5 *Baptimus aquae*: after treatment (photo © Julien Horon).
